PRO-SPEX

606 Main Street, Laurel, Maryland 20707
Framing/Foundation Report 2023 (copy)
Prepared for
Pro Spex
Mar 21, 2023 at 08:00 AM

Framing Report Introduction

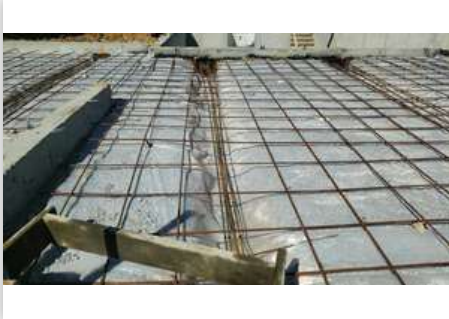
2.1.1 STEEL REBARS NOT TIED IN PLACE

Structural Concern

The steel in the garage slab grade beam is not tied in place. When the concrete is poured, the steel should be evenly spaced inside the concrete when it sets. Failure to correct this will cause the steel placement to move when pouring the slab beams.

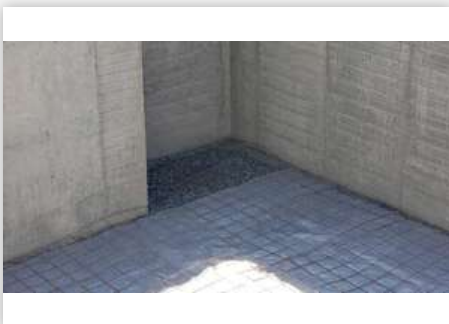
2.2.1 MISSING PLASTIC

Non Structural Concern

The Vapor Barrier is incomplete. Because concrete is porous, missing sections will allow ground moisture into the interior when finished.
