NEW CONSTRUCTION INSPECTION REPORT

Inspection Report
1234 Sample Street, Sample Twon, Maryland 12345

Report ID Inspection Date
AP-293-002701 April 05, 2020 at 06:00 AM

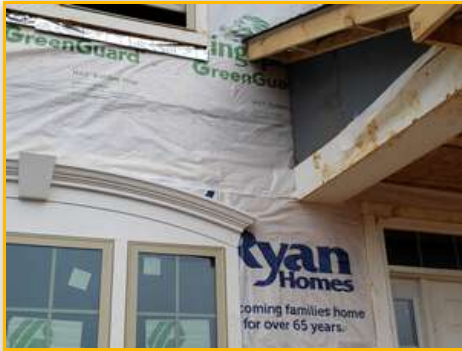
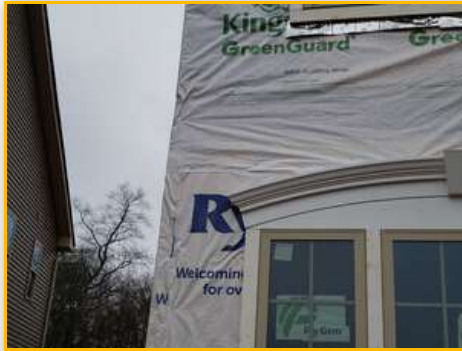
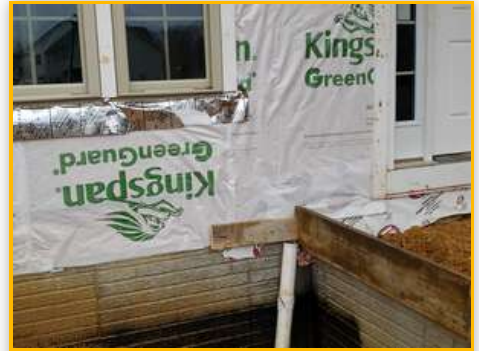
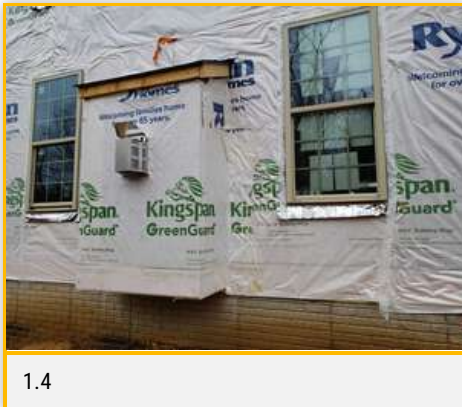
2.1.1 SEAMS NOT TAPED

Overlapping housewrap seams should be taped or caulked according to the manufacturers specifications. Proper installation is essential to ensure moisture control.

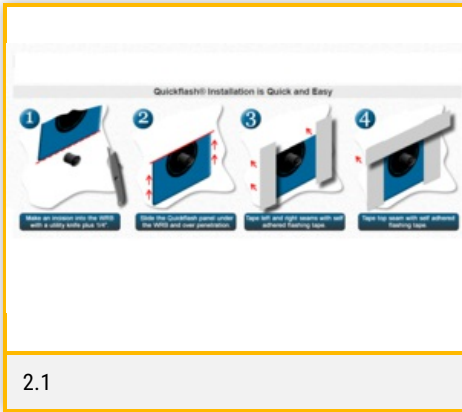
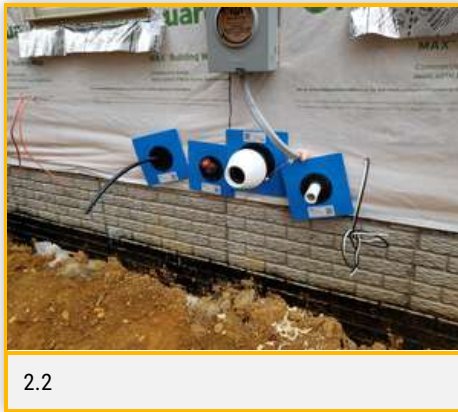
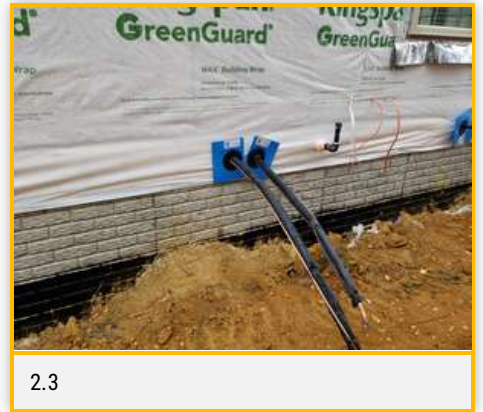
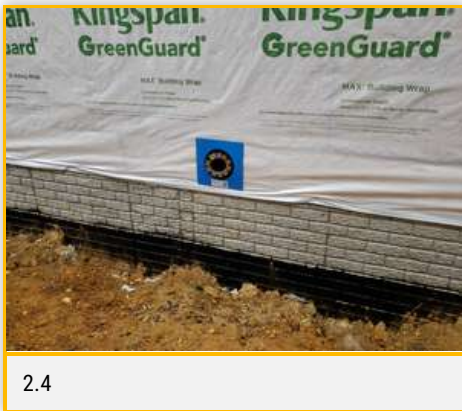
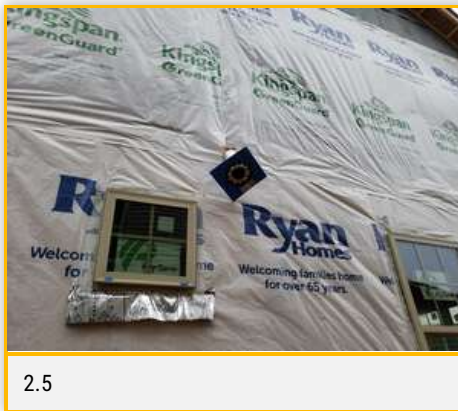
2.1.2 QUICK FLASH INSTALLATION

The "Quick Flash" flashing at wall penetrations not installed according to the manufacturers recommendations. Properly installed, the upper edge should be under the house-wrap and the vertical sides taped, similar to the way windows are taped.

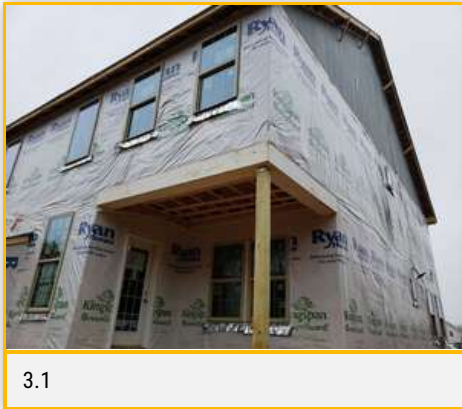
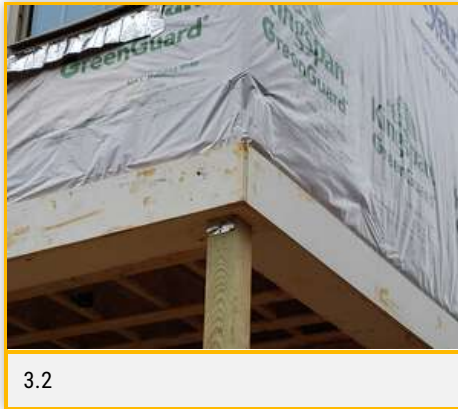
2.1.3 Missing Flashing

House wrap tucked behind finish trim will trap moisture. Check architects intended flashing installation.

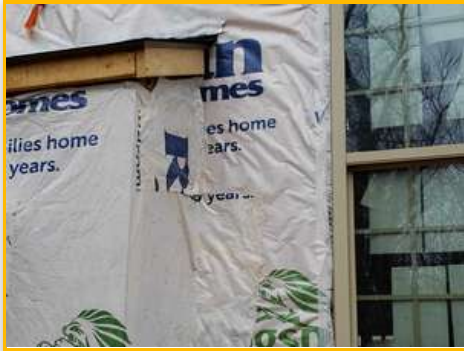
4.1

2.1.4 HOUSE WRAP & FLASHING

2. House wrap overlap must be properly installed. Reverse overlap leads to moisture behind the wrap, which can get trapped and result in long-term damage.

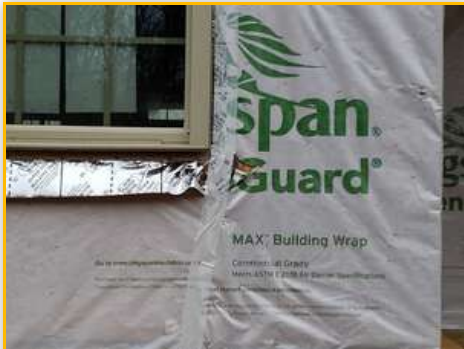
5.1

2.1.5 TORN HOUSE WRAP

All tears in house wrap should be taped. When properly installed the structural sheathing (OSB boards) should be completely wrapped and not exposed to moisture. Proper installation is essential to ensure moisture control.

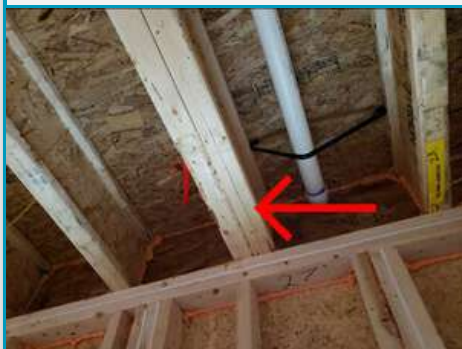
Location: ABOVE MUD ROOM

3.2.1 Damaged Cut TJI

The bottom cord of one floor joists has split. Damaged joists must be properly repaired per the direction of an engineer.

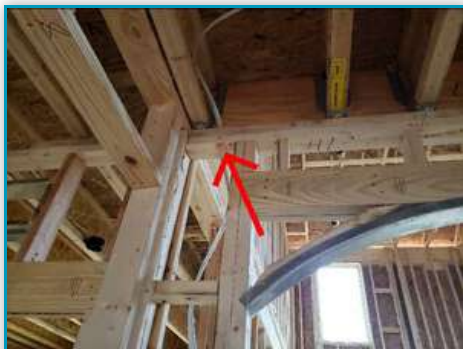
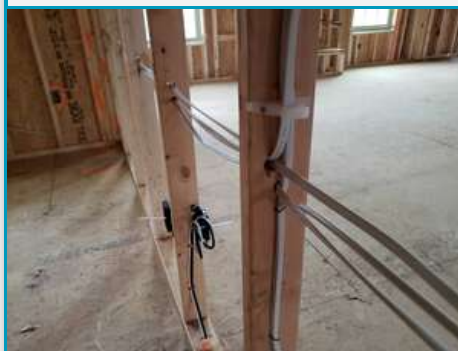
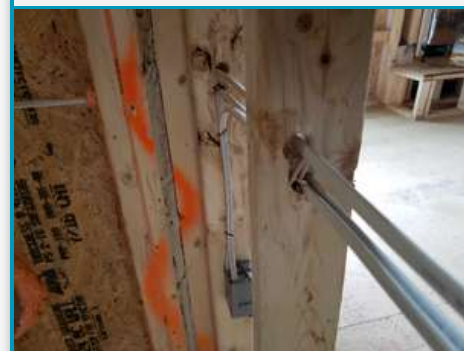
3.3.1 NAIL PLATE PROTECTION

Wall stud cut by plumbing and electrical contractor needs metal plates to protect pipes and wires in many locations. This is required when the edge of the bore or hole is less than 1 1/4 from the edge of the framing member.

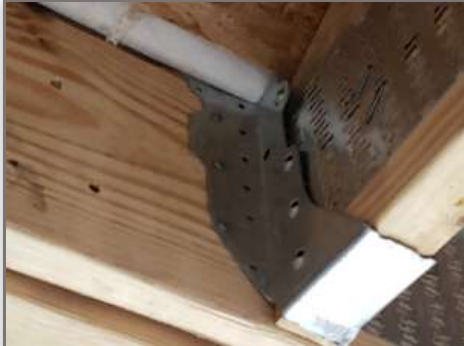
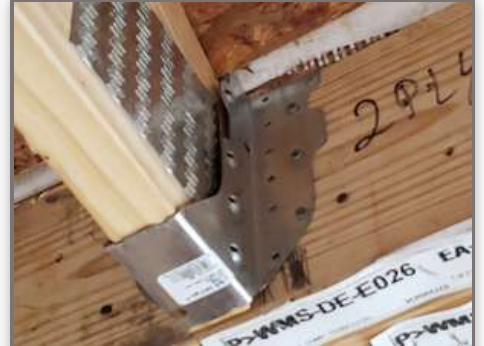
4.1.1 MISSING NAILS IN HANGERS

To provide proper support, all truss hangers should be fully nailed.

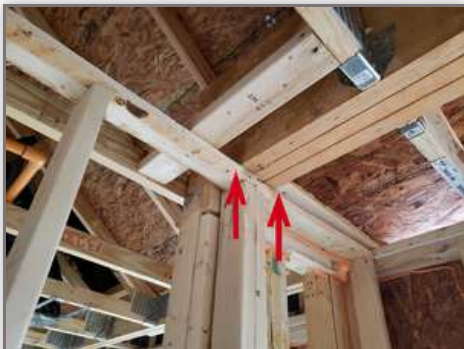
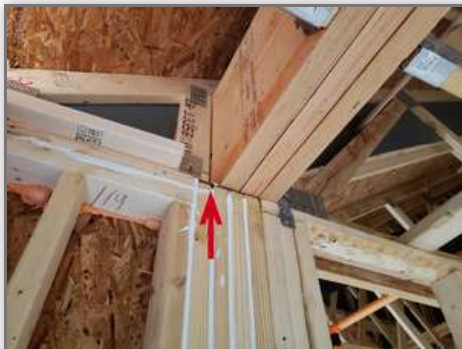
4.1.2 MISSING HURRICANE TIES

Hurricane ties are used at roof trusses ends and all roof framing members where they are attached to the exterior walls. The laminated beam (which typically requires 2 ties per end), has only one tie.

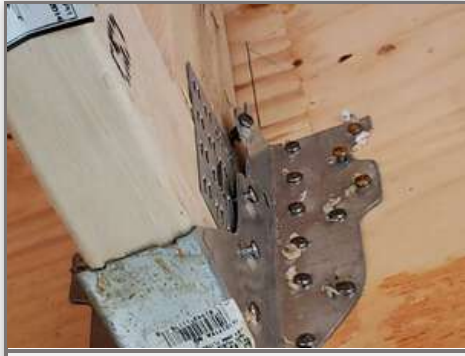
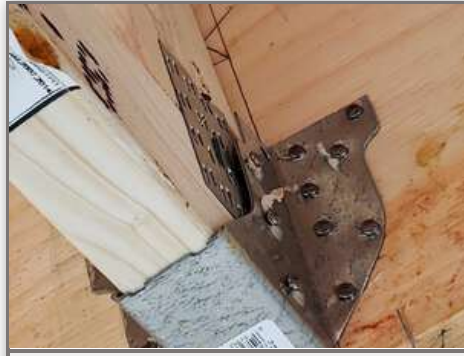
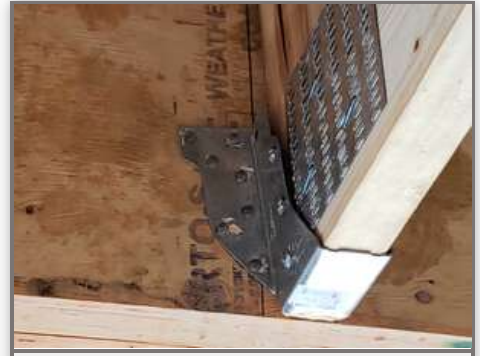
4.1.3 Loose Nailing

Hangers should be nail so that the flange is firmly against the frame.

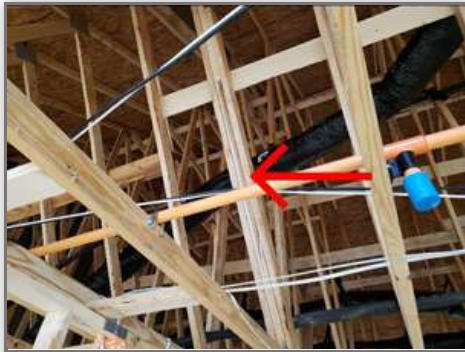
4.1

4.1.4 DAMAGED TRUSS

Damaged roof truss with field repair. This truss must be evaluated by a licensed structural engineer. Adequate documentation of the engineers findings must be provided for each joint, and repairs conducted accordingly. A copy of this documentation should remain with property and transferred to the next owner.

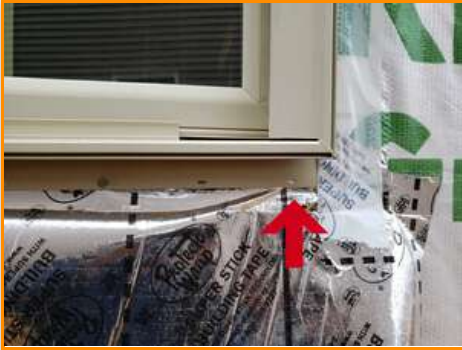
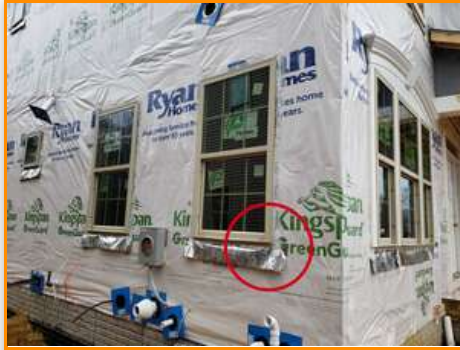
5.1.1 NAILING WINDOWS

All windows should be nailed thru the nailing fin with one nail in ever other hole, per the manufacturers instructions.

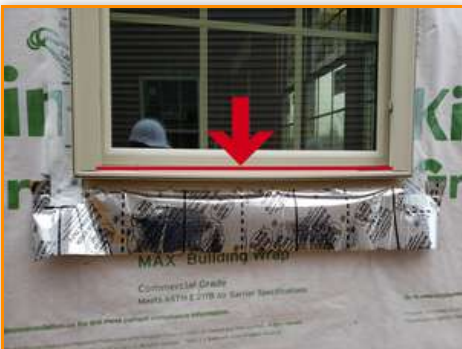
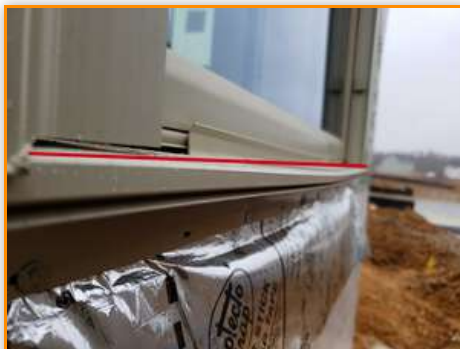
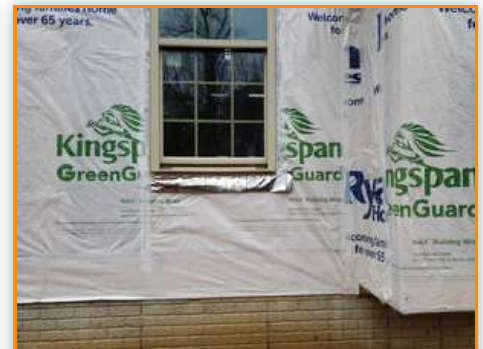
5.1.2 Window Sill Bowed

The bottom of the window frame (the sill) has been bent and nailed in place at several windows. Check all and adjust as needed.

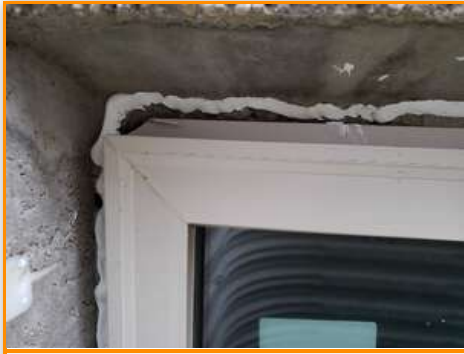
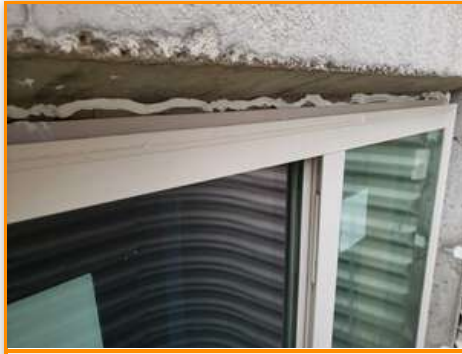
5.1.3 Poorly Applied Caulking

The caulking around the basement window has been poorly applied.

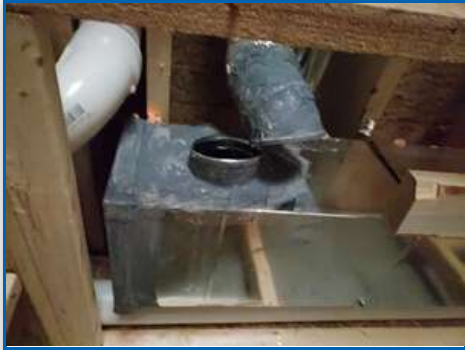
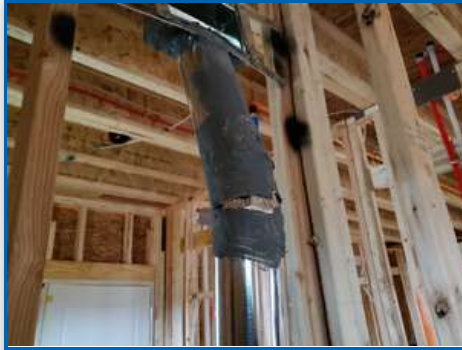
6.2.1 Duct Separation

Supply ducts separated in 2 locations.

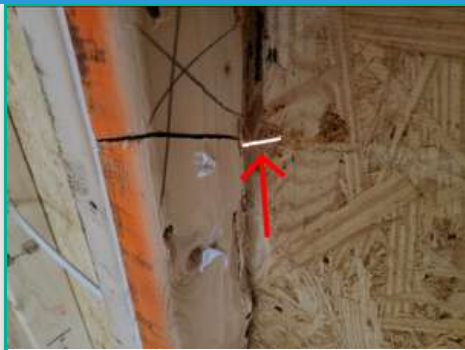
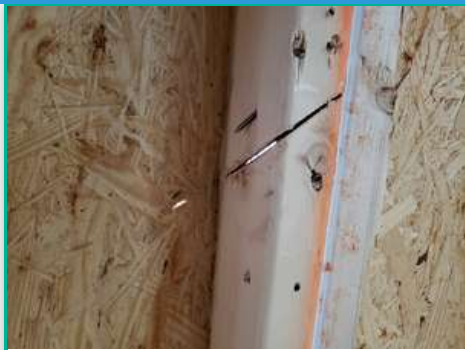
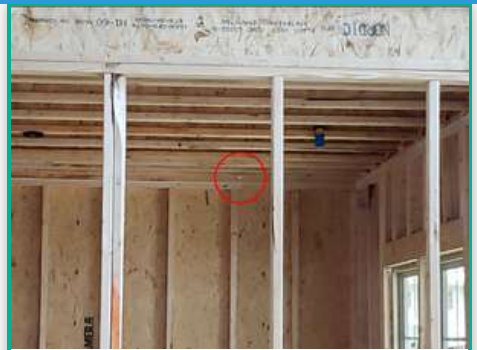
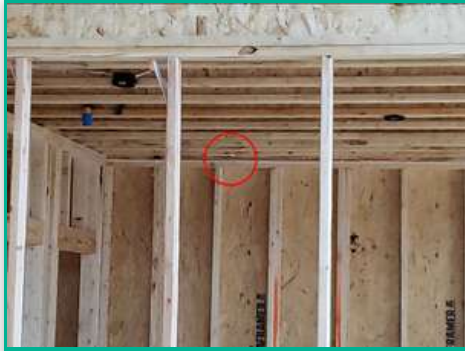
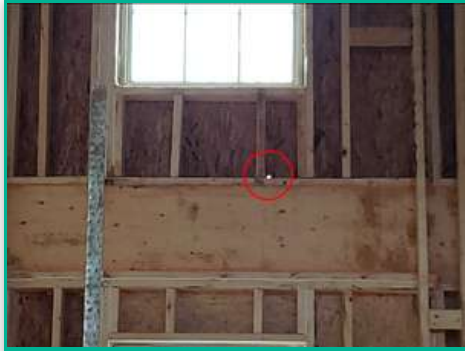
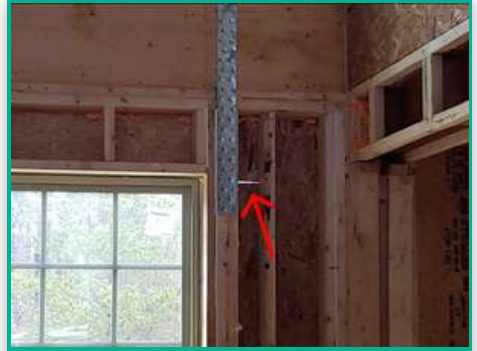
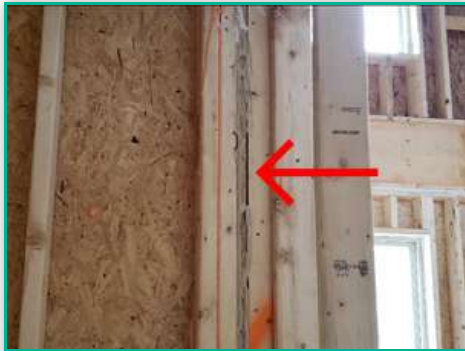
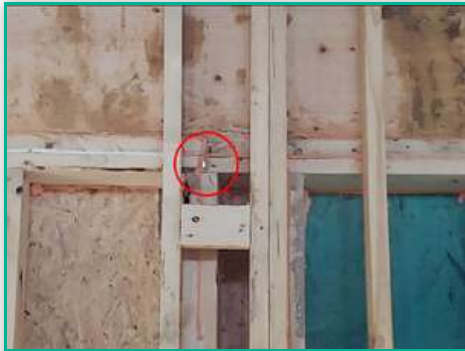
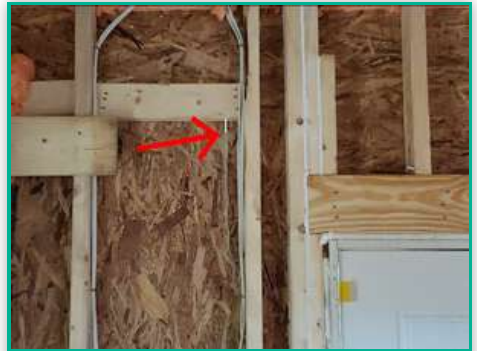
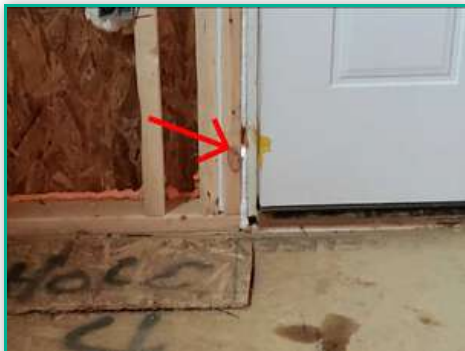
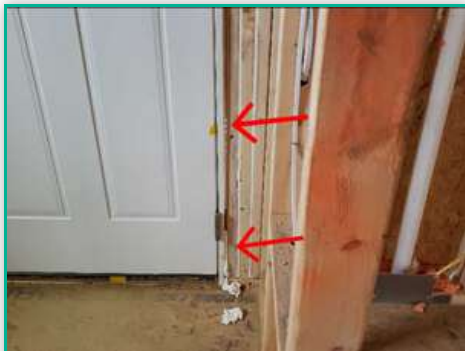
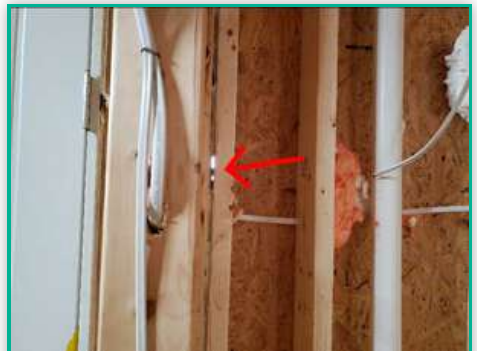
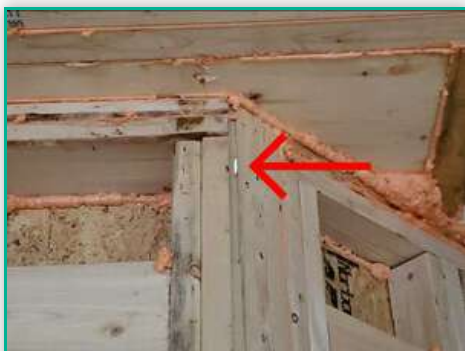
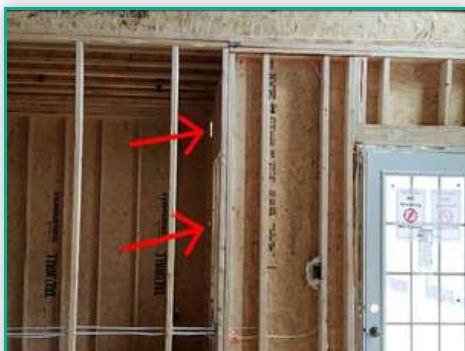
7.1.1 Air seal

There are gaps in the sealant (intended to reduce cold infiltration) applied to the exterior walls in many locations. While some gaps are unavoidable in a home of this size, the number found, mostly on the main floor, should be addressed.

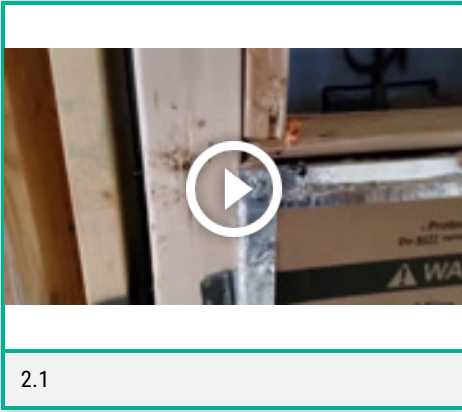
7.1.2 Frame around fireplace loose

The frame around the fireplace is poorly nailed.
