Pro Spex Inc.

The subject property is a two-story industrial/flex building constructed in 2000. The building presents as a multi-tenant facility with numbered suites visible along the front (south) facade. The structure is of tilt-up or pre-engineered panel construction with a painted panel skin in light gray with blue accent banding at the parapet and panel joints. Overall the building appears to be in good condition consistent with its age.

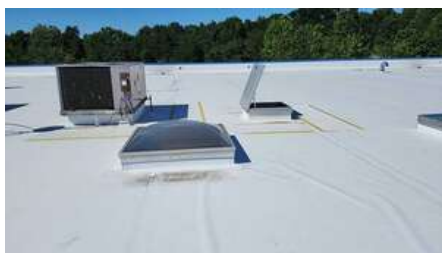
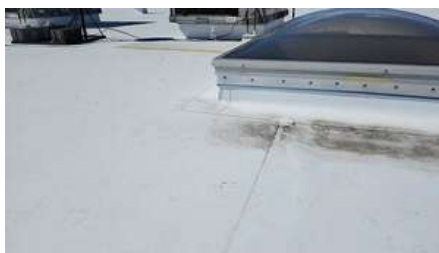
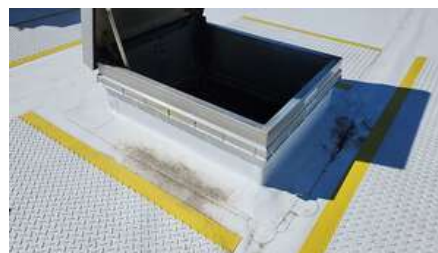
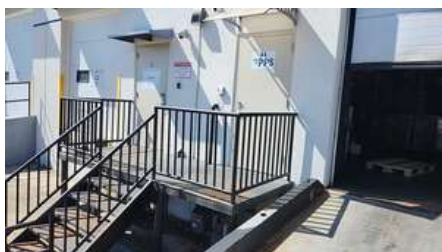
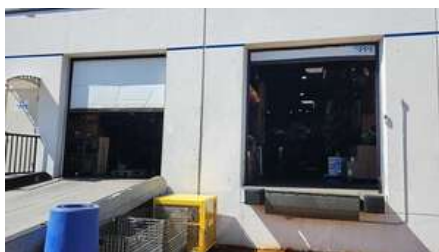
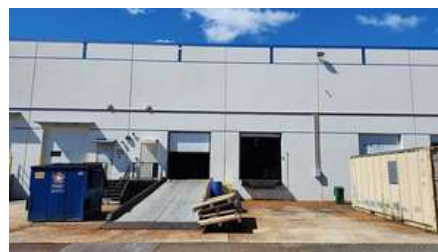
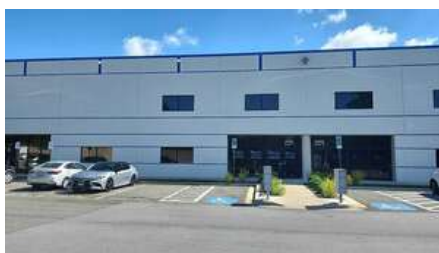
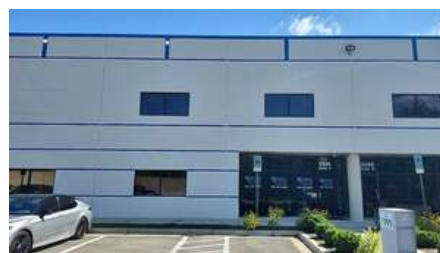
Structural Frame & Exterior Walls: The exterior envelope consists of painted panel cladding with blue accent trim at horizontal joints and at the parapet cap. No significant panel distortion, delamination, or sealant failure was observed at the time of inspection. The building facade appears well-maintained with no visible staining, efflorescence, or structural cracking noted.

Roofing: The roof is a low-slope (flat) system with a white single-ply membrane, consistent with a TPO or PVC installation. The membrane appeared to be in good overall condition with no obvious ponding, blistering, or seam separation observed at the time of inspection. Roof penetrations include at least two rooftop HVAC condensing unit, several dome-type skylight/smoke vent, one operable roof hatch. Walk pads with yellow safety-stripe edging are present around rooftop equipment. The parapet cap is finished in blue to match the building's accent color scheme.

Loading & Site Access: The rear elevation features two overhead loading dock doors and one ground-level drive-in door. A concrete loading apron and dock leveler ramp are present. A dumpster enclosure with a Republic Services container is located adjacent to the loading area. A portable storage/office container is positioned at the right of the loading dock area. Painted dock bay numbering is visible (e.g., Bay 22). Stairway access with metal railing provides entry to an elevated personnel door serving the rear of the building.

Windows & Glazing: The front facade features a ribbon of fixed-pane dark-tinted commercial glazing at the ground-floor storefront level. Second-floor punched windows with dark-tinted glazing are present in a regular pattern across the width of the building. No broken, cracked, or fogged glazing was observed.

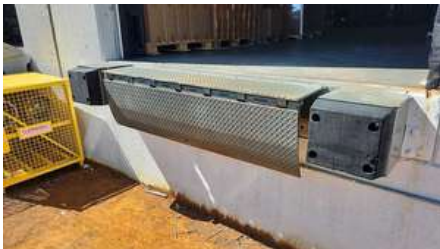
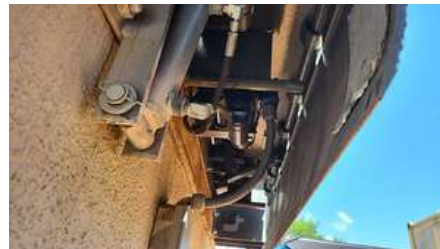
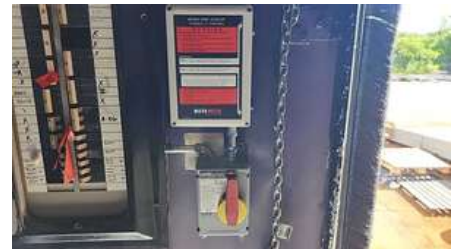
The subject property is equipped with a Rite-Hite Series RHE hydraulic mechanical dock leveler installed at one or more loading dock bays. The leveler is controlled by a wall-mounted hydraulic pushbutton control station and is served by a Leviton industrial safety disconnect switch mounted adjacent to the control panel. A galvanized safety restraint chain is present at the dock opening.

The Rite-Hite Series RHE control placard is clearly posted on the dock wall and includes manufacturer warnings and two-step operating instructions in compliance with OSHA dock safety guidelines. The Leviton safety disconnect switch was observed in the energized (ON) position at the time of inspection. No lockout/tagout (LOTO) device was installed on the disconnect.

Fitting hardware shows surface corrosion consistent with prolonged outdoor/dock exposure.

No active hydraulic fluid leaks were observed at the time of inspection; however, the condition of the hoses suggests elevated risk of future leakage or sudden failure.

The diamond-plate steel deck surface is in serviceable condition with normal wear consistent with regular forklift and pallet jack traffic. The hinged lip extension appeared functional; no significant cracking, warping, or weld failures were observed along the deck perimeter.

A galvanized link safety restraint chain was observed at the dock bay opening. The chain appeared intact and properly anchored. No kinking, broken links, or missing hardware were observed.

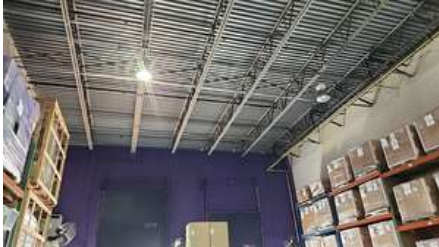
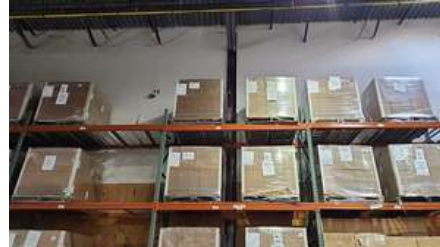
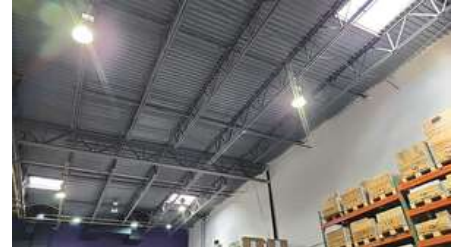
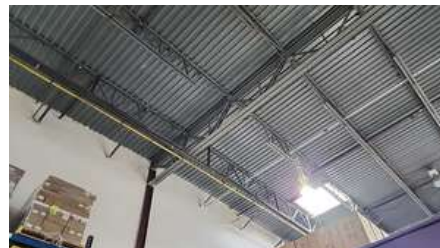
Structural System Open-web steel bar joist roof framing supported by steel columns and bearing walls. Corrugated metal roof deck visible at underside; no concealed ceiling in warehouse area. Structural members appear in serviceable condition with no visible distortion, sagging, or significant corrosion noted at time of inspection.

Floor Slab-on-grade concrete throughout warehouse area. Surface finish consistent with light industrial use. Minor surface staining observed; no significant cracking, heaving, or trip hazards noted in accessible areas.

Interior Walls CMU or metal stud/drywall demising walls at perimeter and tenant separation. Painted finish; accent color (purple/violet) applied to dock-end wall. No significant cracking or moisture staining observed at wall surfaces.

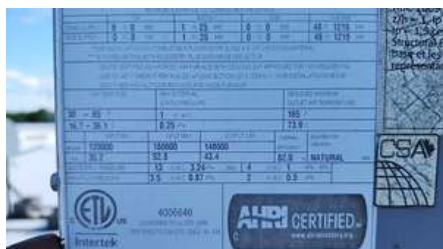
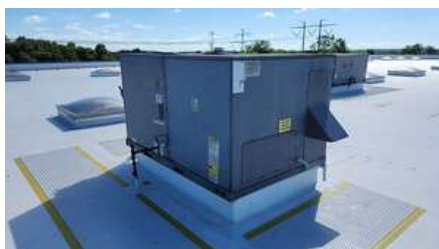
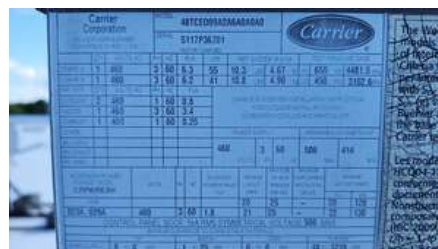
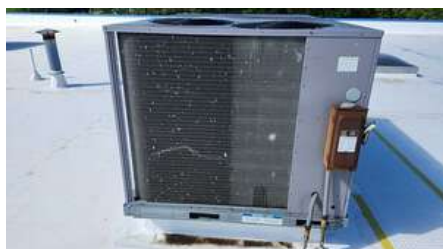
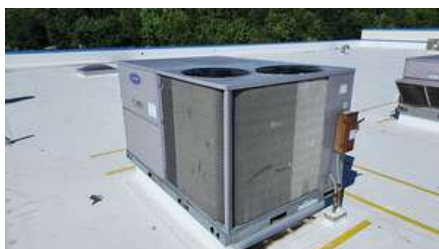
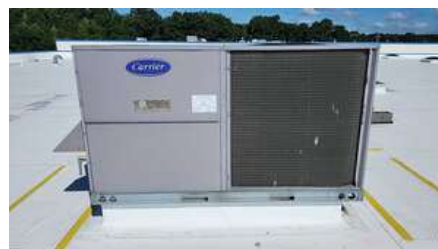
Heating / Central Air Conditioning RTU2 Important Information

Manufacturer: Carrier Corporation Model: 48HJD009---631-- Serial: 1001G34416 Refrigerant: R-22 Power Supply: 460V / 3-Phase / 60Hz Gas Input: 92,000 - 125,000 BTU/hr (Natural Gas) Output Capacity: 75,440 - 102,500 BTU/hr Thermal Efficiency: 82% AFUE Manufacture Date (from serial): 2001 Condition Assessment Two-fan top-discharge packaged gas/electric RTU, roof-curb mounted on white membrane roof. Walk pad and diamond plate access platform present. Cabinet sheet metal exhibited generalized surface soiling, and visible surface corrosion at the base rail/curb consistent with a unit of this age and indicative of deferred maintenance. Condenser coil fins showed heavy debris accumulation and bird fouling across the visible face; coil cleaning is overdue. One condenser fan guard observed. The fresh air intake hood/economizer louver assembly on the side face appeared intact but showed corrosion at the lower frame. A disconnect enclosure with surface oxidation was observed, consistent with the prior unit noted on this roof. Critically, this unit utilizes R-22 refrigerant, which has been phased out under EPA regulations since January 1, 2020. Refrigerant is no longer manufactured; only reclaimed supplies are available at significantly elevated cost. This status materially affects repairability and increases lifecycle risk.

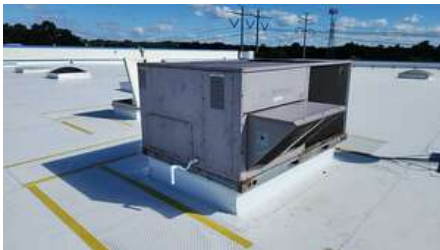
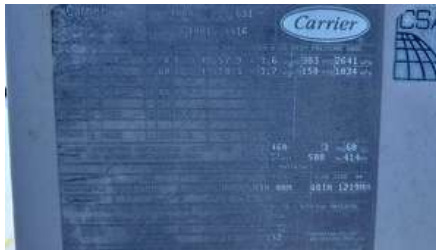
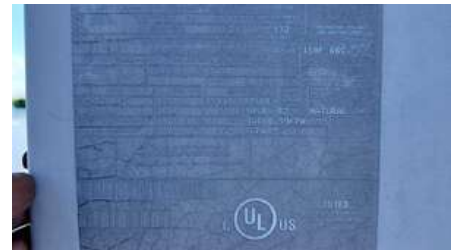
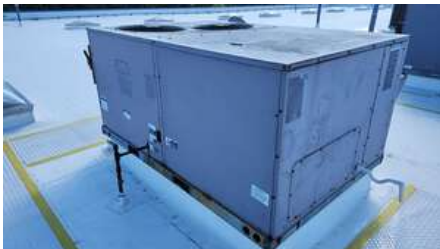
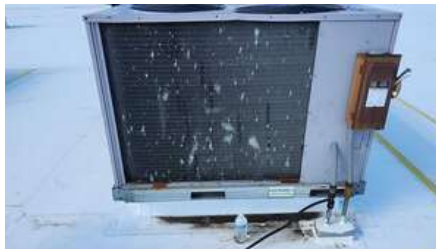
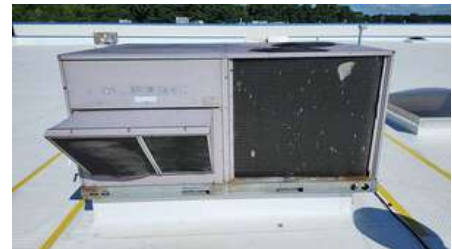
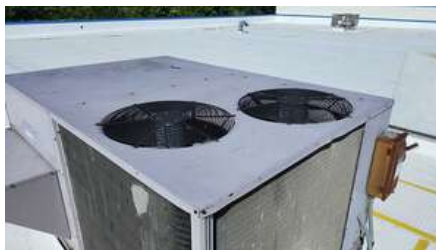
1 R22 DISCONTINUED

The subject unit cooling systems uses R-22 refrigerant. As of January 2020 the EPA mandate that R22 no longer be manufactured or imported into the US. As supplies of R-22 decline it will be costly to repair cooling systems that may need this coolant added. Eventually the coolant will not be available at all. Options include retrofitting older systems to accept R-410 type coolant (this option does not work on all systems), Use your cooling system until it is no longer functional and last is a total cooling system replacement.

Estimated Remaining Useful Life
At approximately 24 years of age, this unit has exceeded its typical useful service life of 15 to 20 years. Replacement should be anticipated in the near term and budgeted accordingly. The R-22 refrigerant status further accelerates the urgency of replacement planning.

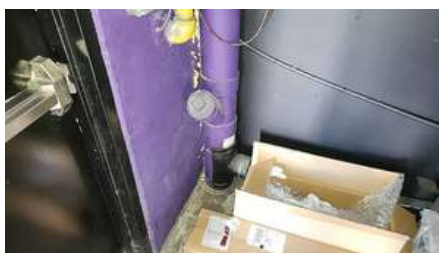
Manufacturer: Bosch (AquaStar) Model: AQ 125-BNG Type: Automatic Instantaneous (Tankless) Gas-Fired Water Heater Serial: 5419212x (partially legible) Gas Input: 28,000 - 117,000 BTU/hr (Natural Gas) Flow Rate: 1.66 GPM (recommended) Vent Diameter: 5.06 inches Standard: ANSI Z21.10.3 / CAN 1-4.3-M98 Manufacture Date: Per data plate standards reference ; exact date not confirmed from serial Unit is wall-mounted in the mezzanine utility area with single-wall galvanized flue vent discharging upward. CSST yellow-jacketed gas supply piping connects at the base. Cabinet appeared intact with no visible damage at time of inspection. A tankless (instantaneous) gas-fired water heater is wall-mounted in the mezzanine utility area. Unit appears to be a Rinnai or similar residential/light-commercial tankless unit based on form factor; make and model not confirmed from data plate at vantage point. Single-flue exhaust vent (galvanized, single-wall) observed discharging upward. CSST (yellow-jacketed) gas supply piping connects to the unit at the base. Unit cabinet appeared intact with no visible damage or corrosion. Manufacture date not confirmed. Gas Distribution Yellow-painted black iron gas piping observed running along the underside of the roof structure in the warehouse bay, supported by pipe clamps at the bar joist level. Piping appeared properly supported at observed intervals. A union/shutoff fitting visible at a branch tee. CSST (yellow jacket) transitions observed at the water heater connection and at wall penetration. A PVC sanitary stack with a cleanout fitting was also observed at the base of a wall, consistent with floor drain or lavatory service in that zone. General Observations No active leaks, significant corrosion, unsupported spans, or code-apparent deficiencies were observed in accessible and visible plumbing components at the time of inspection. Piping in the utility/mezzanine area showed minor surface oxidation consistent with age and environment; no conditions requiring immediate action were identified from accessible vantage points.

1 WH OLD NOT OPERATING

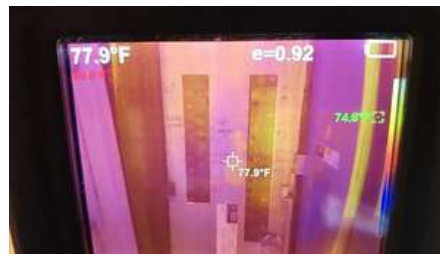
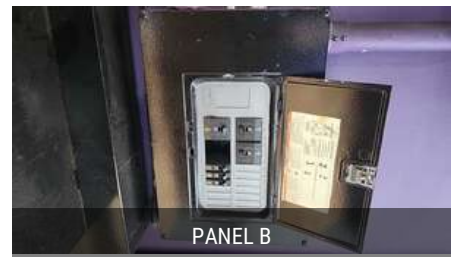
PANEL B

Exterior/Semi-Exposed Location, Condition of Enclosure The smaller panelboard labeled "B", is located in what appears to be an exterior or semi-exposed wall cavity adjacent to loading dock / warehouse perimeter wall. The enclosure exhibits surface corrosion and weathering on the exterior cover and surrounding structure. Unprotected conductor (bare copper or similar) was observed. This condition should be evaluated by a licensed electrician and corrected as needed to comply with NEC 230 and 300 series requirements for weatherproofing and conductor protection.

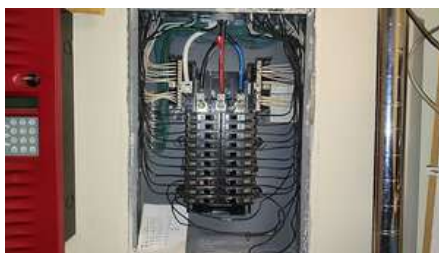
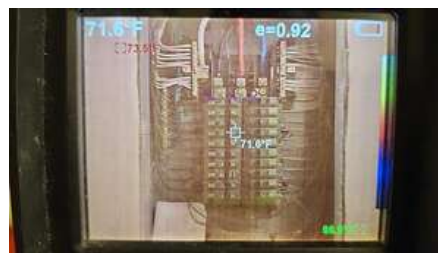
SUB PANEL

5 LOOSE WIRES IN PANEL

6 PANEL OPENINGS(MISSING KNOCKOUTS)

All open and unused breaker positions (missing knockouts) in the panel front should be closed off.
