NEW CONSTRUCTION INSPECTION REPORT

Inspection Report
1234 Sample Street, Sample Twon, Maryland 12345

Report ID Inspection Date
AP-293-002701 April 05, 2020 at 06:00 AM

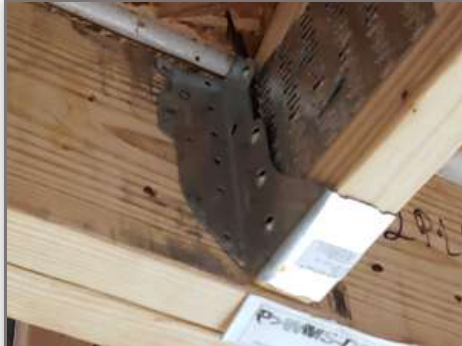
1.2

4.1.1 MISSING NAILS IN HANGERS

To provide proper support, all truss hangers should be fully nailed.
